Yessine AYED, Guénaél GERMAIN - High-pressure water-jet-assisted machining of Ti555-3 titanium alloy: investigation of tool wear mechanisms - International Journal of Advanced Manufacturing Technology - Vol. 96, n°1-4, p.845-856 - 2018

High-pressure water-jet-assisted machining of Ti555-3 titanium alloy: investigation of tool wear mechanisms

Abstract

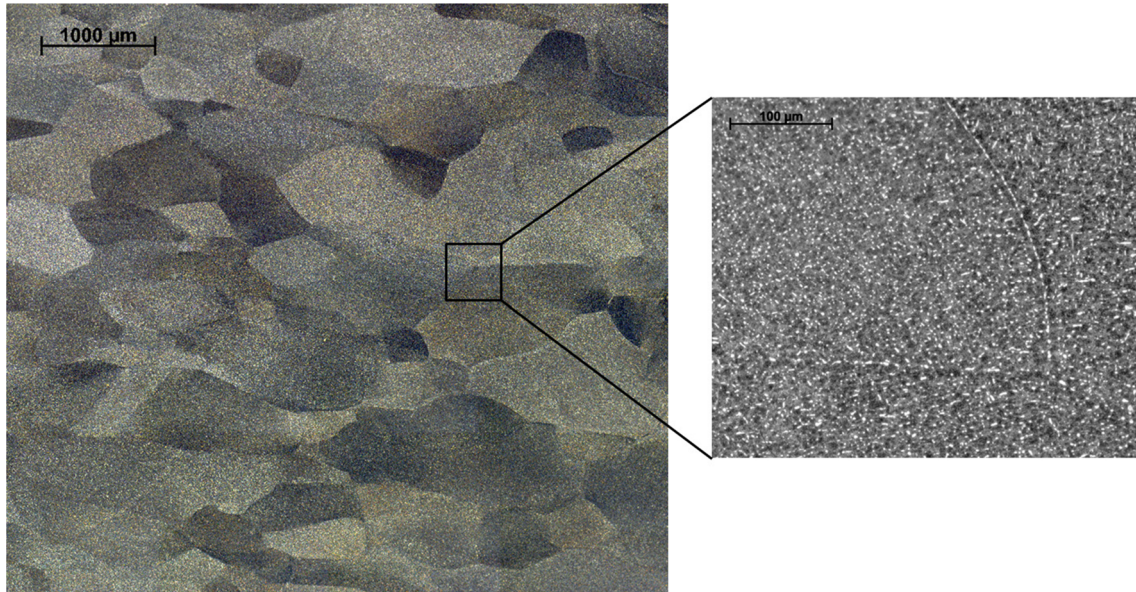
Fig. 1 Microstructure of the Ti555-3 alloy

The Ti555-3 near-beta titanium alloy was selected for this study. It has improved mechanical properties compared to the Ti-10V-2Fe-3Al alloy and is mainly intended for landing gear and other aeronautical structural components. It also has high hardenability, high fracture toughness and a good strength to weight ratio [28, 29]. The microstructure of the as-delivered material, etched with Kroll's reagent, is shown in Fig. 1. It displays a two-phase microstructure: lamellar and globular α phase within the β matrix.

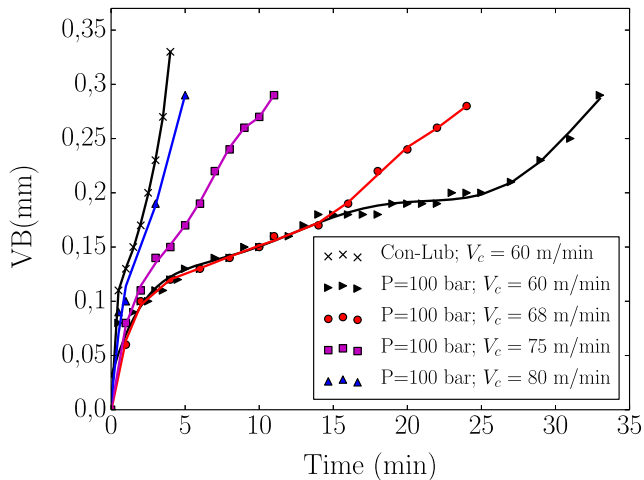
**Fig. 3** Influence of the cutting speed and the high-pressure water-jet assistance on tool life ($a_p = 1.5$ mm, $f = 0.1$ mm/rev)

Figure 3 demonstrates that the cutting speed could be further increased to 75 m/min while maintaining an acceptable tool life of up to 11 min. Beyond this speed, HPWJA is no longer efficient. The acceleration of wear as a consequence of an increase in cutting speed is mainly related to the activation of different tool wear mechanisms. During the cutting process, heat is generated in the cutting zone due to plastic deformation and friction. The amount of heat generated is increased by an increase in the cutting speed. As reported by Moura et al. [10],

at the cutting edge, the temperature may reach 1000 °C. Hence, the high temperature levels accelerate diffusion and adhesion (plucking mechanism) [10]. In the case of HPWJA, the lubricant jet insures good cooling of the cutting zone, thereby slowing tool wear evolution. However, the progressive increase of the cutting speed leads to a rapid temperature increase that the lubricant jet cannot evacuate quickly. This finally leads to a reduction of the HPWJA efficiency (80 m/min).

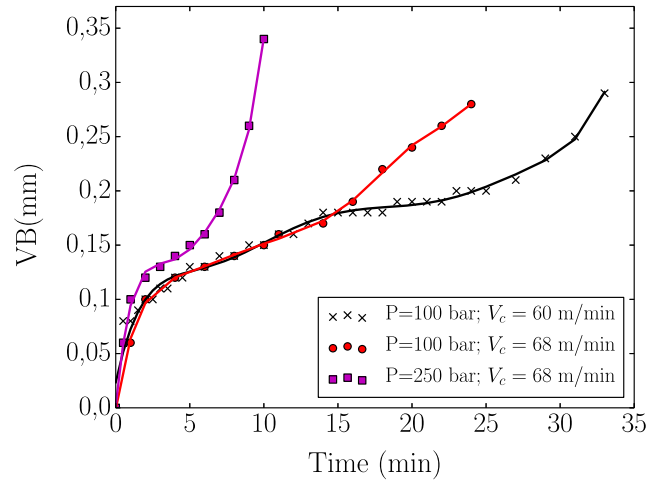
**Fig. 4** Influence of the cutting speed and coolant pressure on tool life ($a_p = 1.5$ mm, $f = 0.1$ mm/rev)

This part of the study has been achieved by a comparative analysis of the impact of the lubricant-jet pressure on tool life. Figure 4 illustrates the evolution of the tool wear curves. It shows that a pressure increase causes a considerable decrease in tool life.

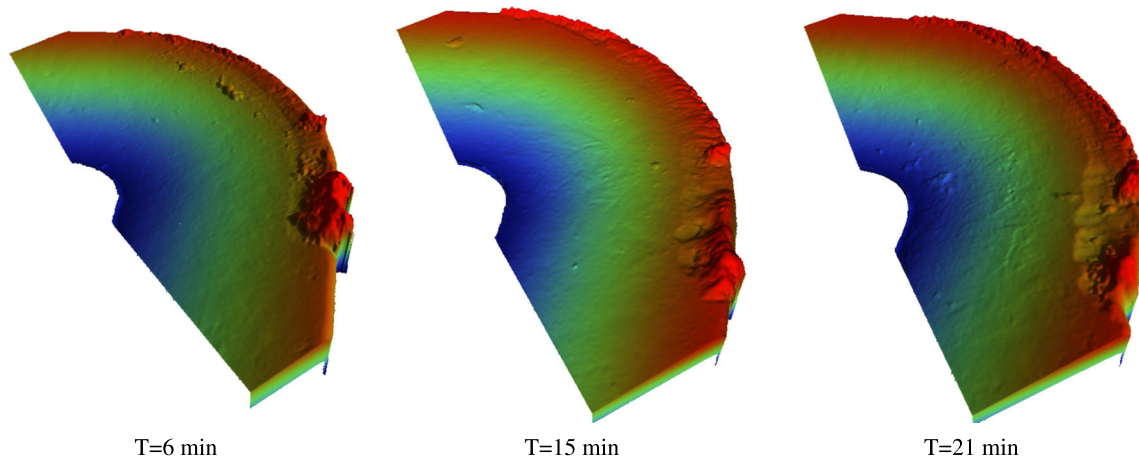
Fig. 5 Tool wear evolution ($P = 100$ bar)

For both cases, observations of the tool using a stereo microscope revealed the formation of a crater at the cutting face. To get more information about tool wear evolution and mechanisms, cutting tools have been analysed using a 3D profilometer and a SEM. Figures 5 and 6 show different stages of crater formation.

For a pressure of 100 bar, tool wear evolves gradually and crater wear takes place only after 15 min of machining. However, for a pressure of 250 bar, excessive tool wear

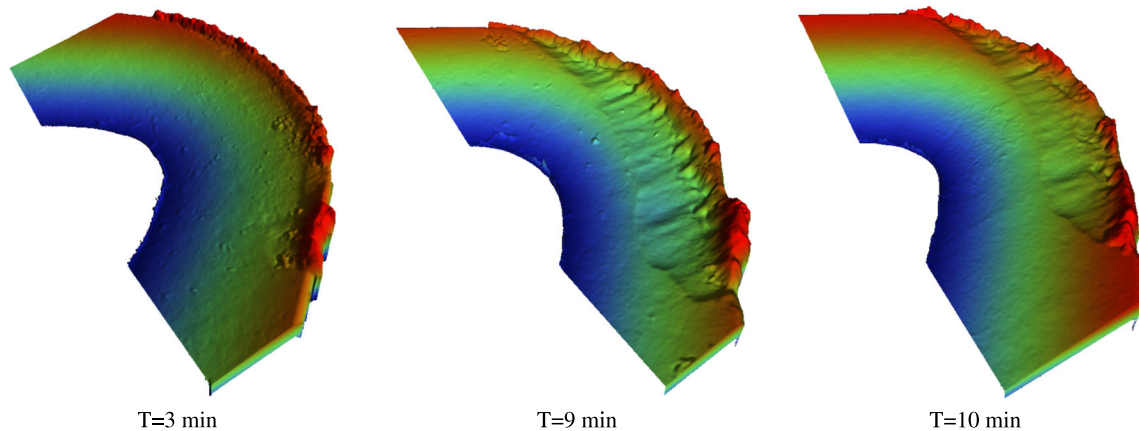
Fig. 6 Tool wear evolution ($P = 250$ bar)

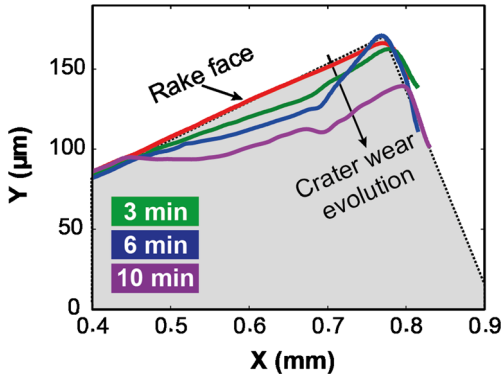
Fig. 7 Crater wear evolution ($P = 250$ bar)

is seen, notably at the level of the tool rake face. The crater becomes larger and deeper as shows by Fig. 7. The progressive formation of the crater weakens the cutting tool. Hence, machining up to 10 min has caused the cutting edge to break and substantial material chipping.

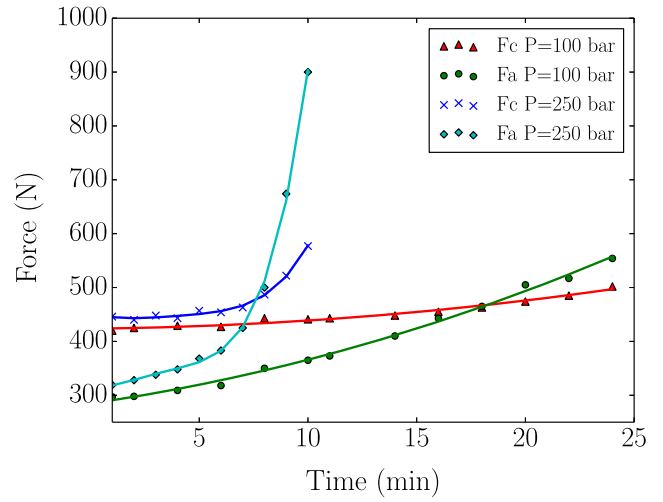
Fig. 10 Evolution of the cutting forces

The evolution of the mean arithmetic (average value) cutting force and the axial force (F_c , F_a) during machining is presented in Fig. 10. It can be seen that for 100 bar, the cutting force evolves gradually. However, for 250 bar, a sharp and rapid evolution can be observed. This could be linked to flank wear, crater wear and material chipping at the cutting edge which causes a local change of the tool geometry, cutting angles and contact length.

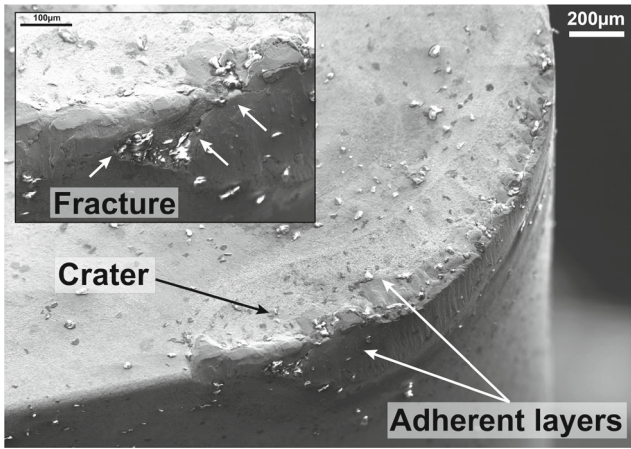
Fig. 8 SEM observation of tool wear ($P = 250$ bar, $T = 9$ min)

The SEM observations, illustrated in Fig. 8, show the existence of adherent layers on the tool rake and flank faces. The parallel scratches on the tool flank face are a sign of abrasion wear. Micro-cracks have also been detected and they are mainly due the combination of tool stiffness degradation and high cutting forces.

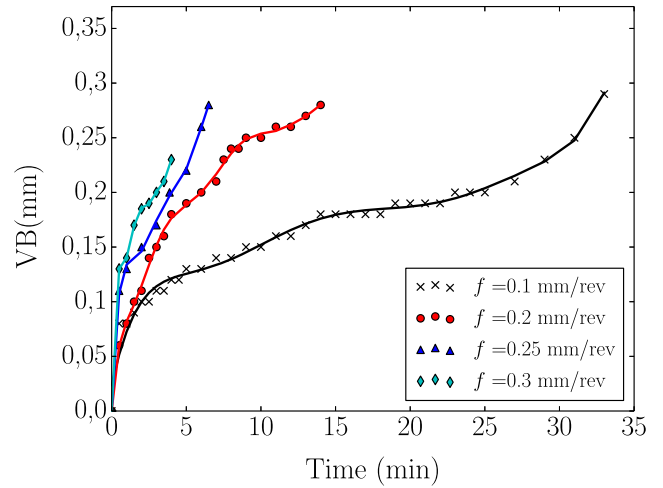
Fig. 11 Feed rate influence ($a_p = 1.5$ mm, $V_c = 60$ m/min, $P = 100$ bar)

At a cutting speed of 60 m/min and a pressure of 100 bar, the feed rate has been varied from 0.1 to 0.3 mm/rev. The experimental results are plotted in Fig. 11. It shows a sharp decrease in tool life (at least 50%); tool life does not exceed 4 min at 0.3 mm/rev. Also, for high feed rates, a large notch occurs and weakens the tool insert. In this context, it is necessary to point out that under these conditions and with conventional lubrication, machining of the Ti555-3 alloy is almost impossible (only 5 min at 0.1 mm/rev). Machining is accompanied by high temperature generation and smoke that ends by the collapse of the cutting edge after a few seconds.

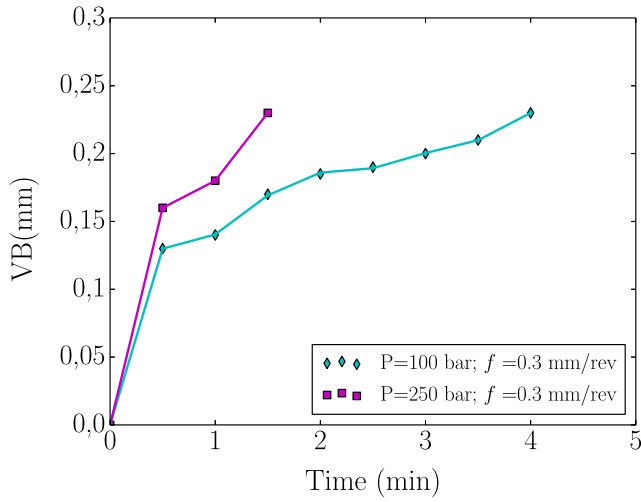
Fig. 12 Feed rate and pressure influence ($a_p = 1.5$ mm, $V_c = 60$ m/min)

Figure 12 emphasizes the influence of the water-jet pressure at 100 bar and 250 bar. Tests have been stopped at $VB = 0.23$ mm to preserve the highly damaged cutting edge for further analysis. As well as the last tests, the increase of pressure leads to a more degradation of the tool.

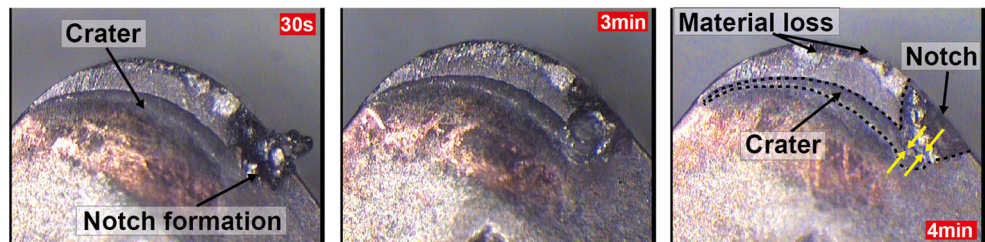
Fig. 13 Observation of tool wear evolution on the tool rake face ($a_p = 1.5$ mm, $f = 0.3$ mm/rev, $V_c = 60$ m/min, $P = 100$ bar)

Monitoring of tool wear evolution using a stereo microscope is illustrated in Fig. 13. It shows that after only 30 s, severe wear has taken place. A notch and a crater have been formed; material chipping has been observed on

the cutting edge. Over time, tool wear evolves rapidly; the notch becomes larger and reaches the crater. At this point, the tool tip becomes very fragile and it could collapse under the action of the increasing cutting forces, even if the flank wear remains stable.

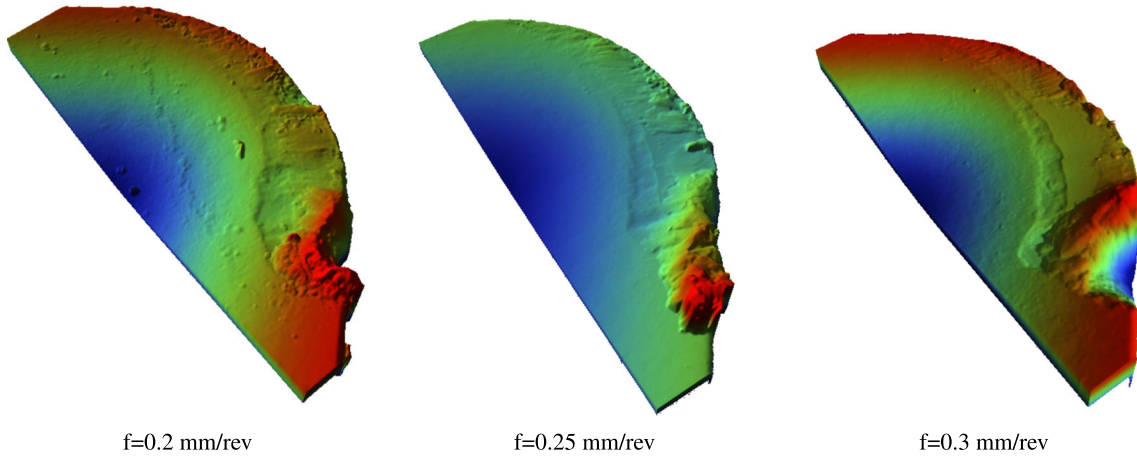
Fig. 14 Tool wear at the end of tool life ($a_p = 1.5 \text{ mm}$, $V_c = 60 \text{ m/min}$, $P = 100 \text{ bar}$)

For a more exhaustive tool wear analysis, tool inserts have been observed using a SEM and scanned using a 3D profilometer. Figure 14 shows the scanned surfaces of the cutting tools at the end of the tool life. Figures 15 and 16 show the SEM observations of the worn tools.

These analysis have permitted a closer view of the damaged areas. Material deposits (adherent layers) and material chipping are clearly distinguishable ($f = 0.2$ mm/rev and $f = 0.3$ mm/rev) on the flank face, the rake face and the notch. For a feed rate of 0.3 mm/rev, the tool seems to have undergone very severe thermo-mechanical loads, given the significant deterioration of the cutting edge. Indeed, a large notch of approximately 400 μ m wide and material chipping along the cutting edge have occurred in only 4 min.

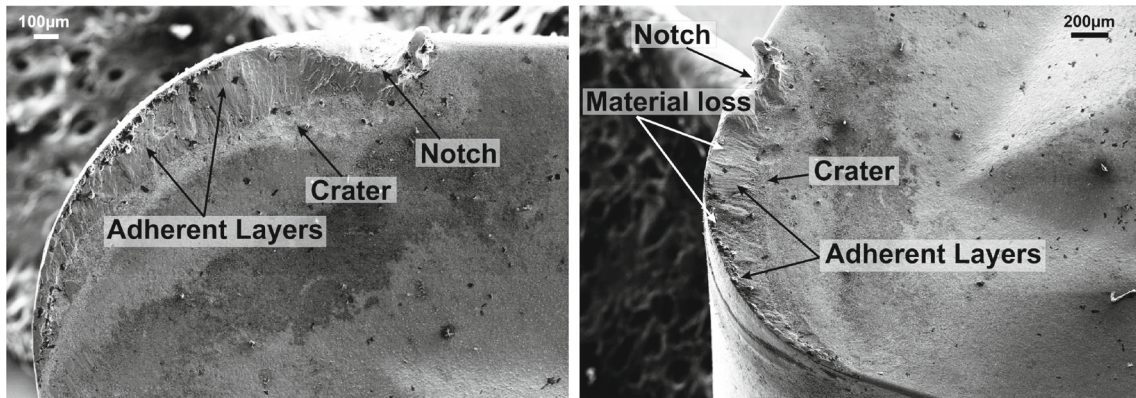
Fig. 15 Tool wear $f = 0.2 \text{ mm/rev}$ ($a_p = 1.5 \text{ mm}$, $V_c = 60 \text{ m/min}$, $P = 100 \text{ bar}$)

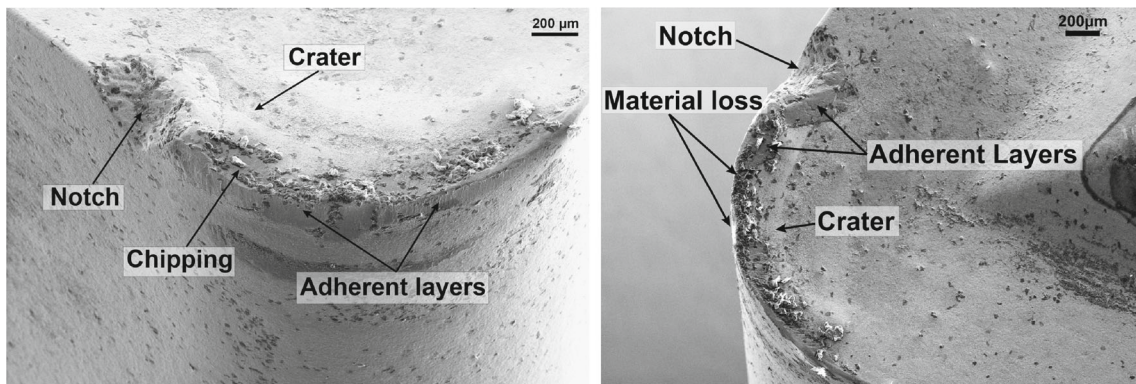
Fig. 16 $f = 0.3 \text{ mm/rev}$ ($a_p = 1.5 \text{ mm}$, $V_c = 60 \text{ m/min}$, $P = 100 \text{ bar}$)

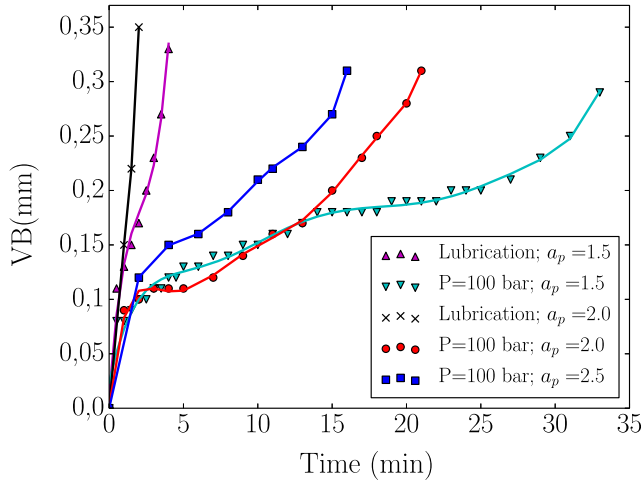
Fig. 17 Depth of cut impact ($f = 0.1$ mm/rev, $V_c = 60$ m/min)

A final series of tests have been carried out in order to investigate the impact of the depth of cut on tool wear using HPWJA. The depth of cut has been varied from 1.5 to 2.5 mm ($f = 0.1$ mm/rev, $V_c = 60$ m/min). The results of these tests are presented in Fig. 17.

First of all, it could be noted that the Ti555-3 titanium alloy is almost not machinable under these cutting conditions, using conventional lubrication; the tool life does not exceed 2 min at $a_p = 2.0$ mm. However, the use of the high-pressure water-jet assistance significantly increases tool life. Indeed, for $a_p = 1.5$ mm, tool life has been multiplied by a factor of 8 and for $a_p = 2$ mm, it has been multiplied by a factor of 10 (from 2 to 21 min).

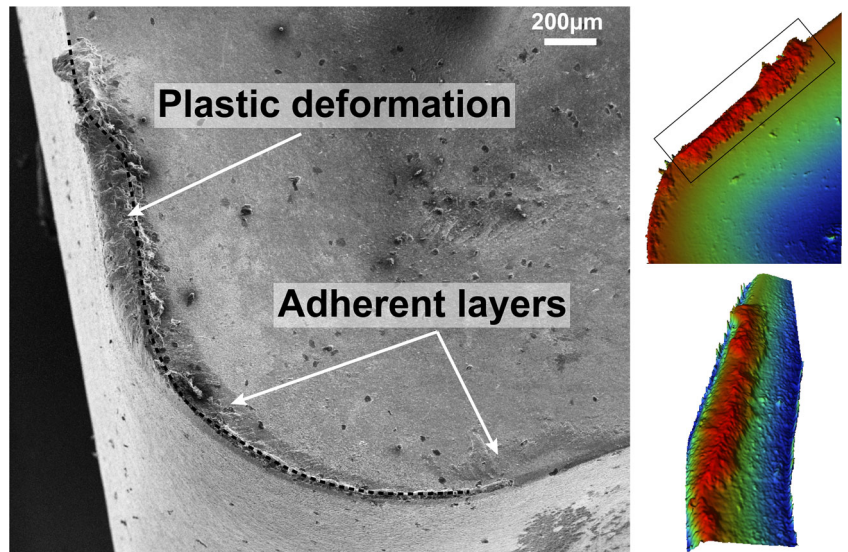
Fig. 18 Plastic deformation of the cutting edge (conventional lubrication, $a_p = 2$ mm, $T = 2$ min)

collapse [34]. This has been confirmed by analyses using the SEM and the 3D profilometer. Figure 18 illustrates the plastic deformation at the cutting edge (conventional lubrication); the cutting edge has been deformed by approximately 0.15 mm.

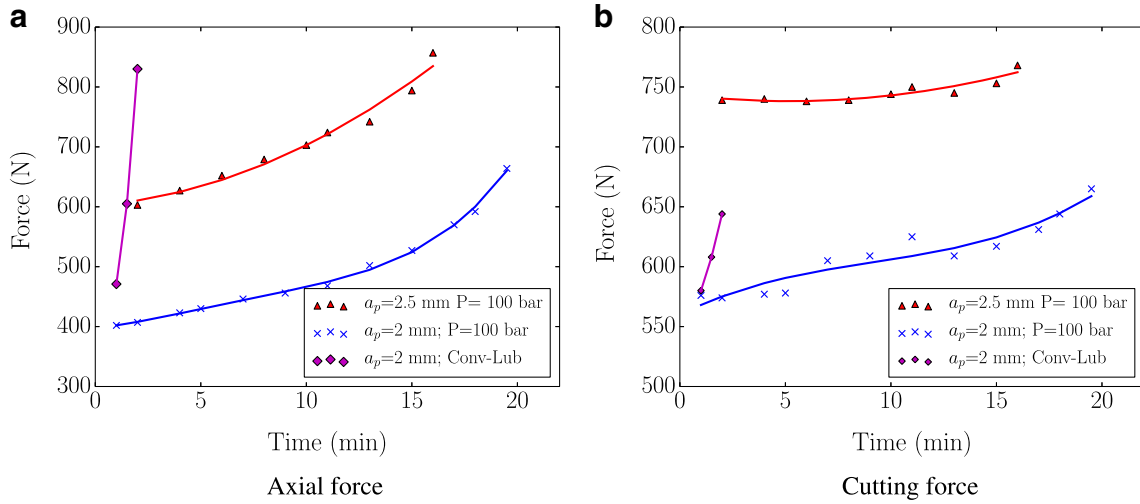
Fig. 19 Cutting force evolution

The evolution of the cutting forces is provided by Fig. 19. Hence, it can be deduced that the initial specific cutting force ($K_c = \frac{F}{a_p f}$) is approximately 2800 MPa and it reaches 3520 MPa at the end of the tool life. This further explains the plastic deformation phenomenon which has occurred. On the bases of the work by Astakhov [34], to prevent thermal softening of tungsten carbide, the temperature should not exceed 800 °C for such a loading level. However, this temperature is far exceeded during machining of titanium alloys even for a lower cutting conditions [35]. In the case of water-jet assistance, a large part of the generated heat is evacuated.

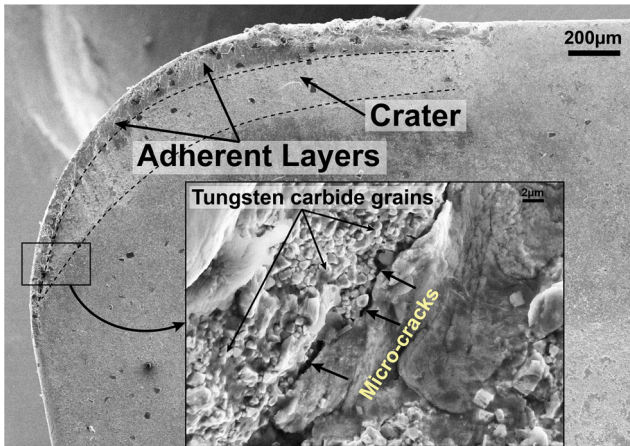
Fig. 20 Tool wear: $a_p = 2$ mm, $P = 100$ bar, $T = 19$ min

The efficient lubrication provided by the high-pressure water jet avoids the plastic deformation wear mechanism. Figure 20 shows the rake face of the tool at the end of the tool life (19 min). It shows the zones of material adhesion and a large crater; it also shows micro-cracks on the border between the crater and the cutting edge. The gradual formation of the crater under the action of the adhesion mechanism (accelerated by the water jet) weakens the tool. Meanwhile, wear on rake and flank faces leads to an increase in the cutting forces. At this time, micro-cracks begin to form; this will end by the rupture of the cutting edge.
